Cedar Bluff District Fisheries

Kansas Department of Wildlife, Parks, and Tourism Fisheries Division
Newsletter Date: September 2019 Volume 9, Issue 2

Cedar Bluff Reservoir Water Level Increase

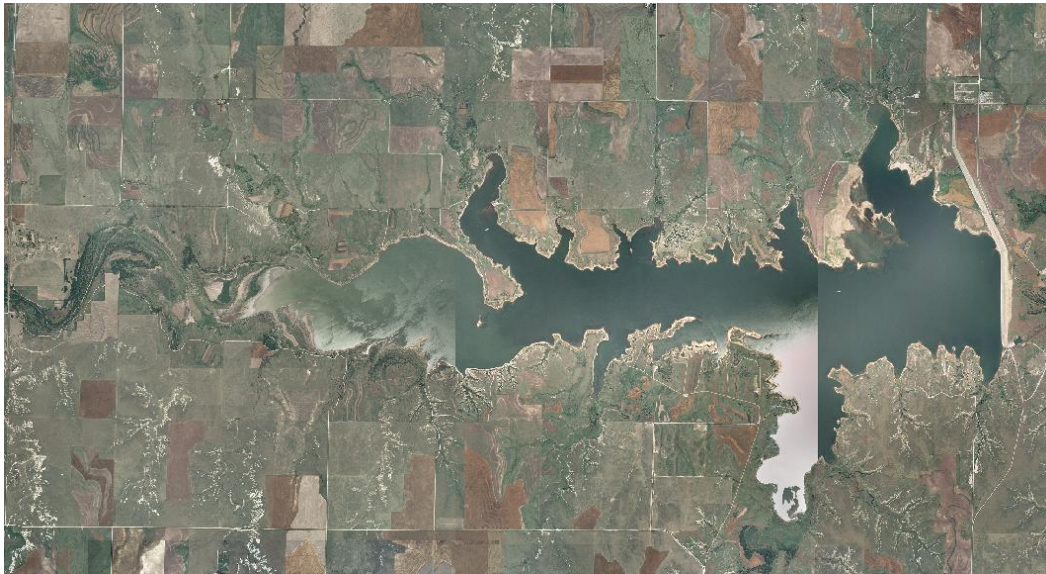
Cedar Bluff Reservoir in 2005 approximately 11 feet below full pool

The Cedar Bluff Reservoir water level has realized a net increase of 16.3 feet bringing the reservoir elevation to 10.7 feet below full pool. With the elevation increase, reservoir surface area increased from 2,767 acres to 4,908 acres. Further, reservoir volume increased from 28.6% to 63.0% of full capacity. The last time the reservoir water level was at this most recent elevation was July 2005.

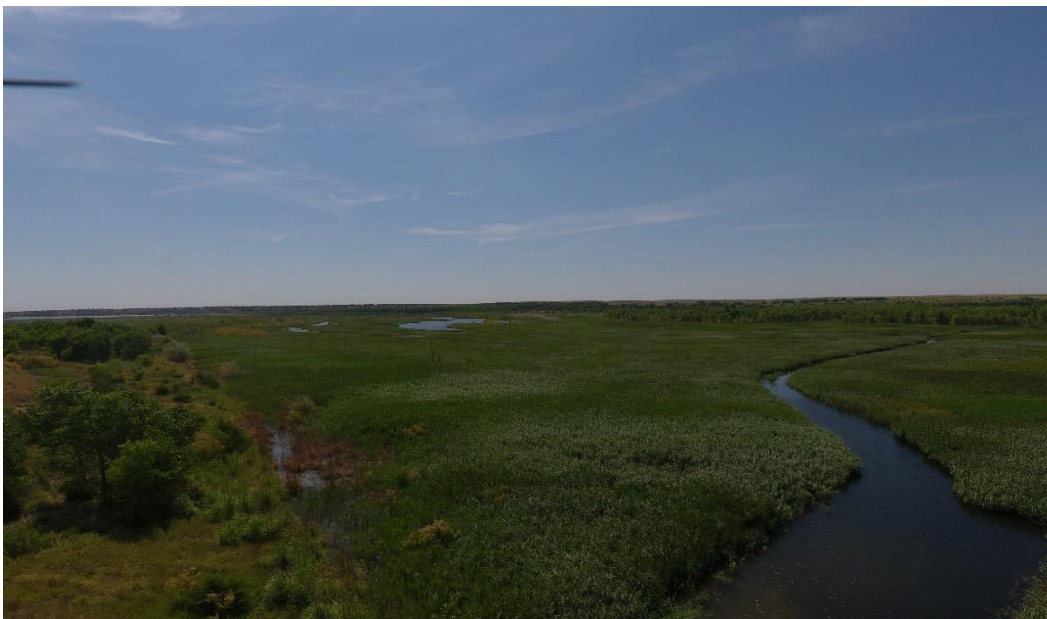
Hundreds of acres of flooded terrestrial vegetation toward the west end of Cedar Bluff Reservoir

The 16 foot water level fluctuation that occurred from 2005 to present allowed terrestrial vegetation to colonize dry areas of the reservoir basin. The recent refilling flooded over 2,200 acres of new fish habitat. This change in habitat characteristics will likely change the composition of the fishery over the next several years.

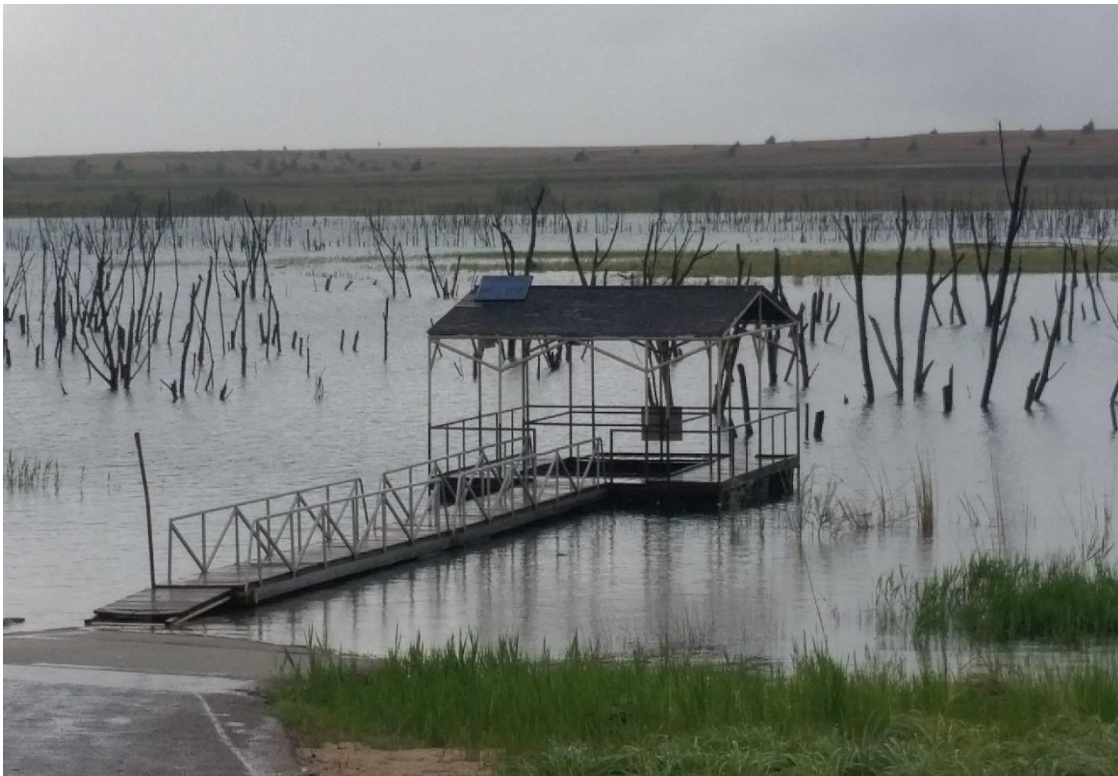
Cedar Bluff fishing dock with old shingled roof

Maintenance included; repainting, repair to walkway due to storm damage, and replacement of floatation system. The dock's roof had previously been shingled twice. But this past summer crumbling shingles and rotten roof sheeting necessitated roof replacement. To accomplish the maintenance, the dock was left in place on the water, existing shingles and tar paper torn off, rotten sheeting replaced, and new tar paper and roof tin was installed.

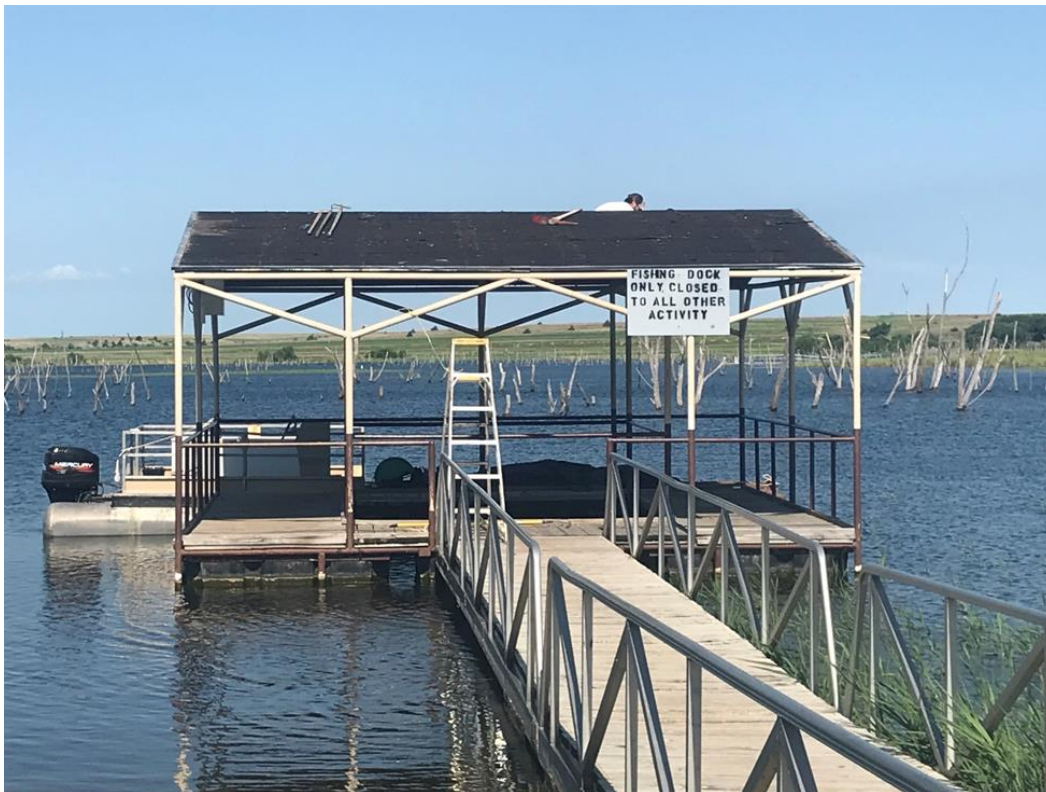
Cedar Bluff fishing dock during roof tear-off, note the habitat barge on the far side of the dock used to contain and transport torn off shingles and tar paper back to the shore for disposal

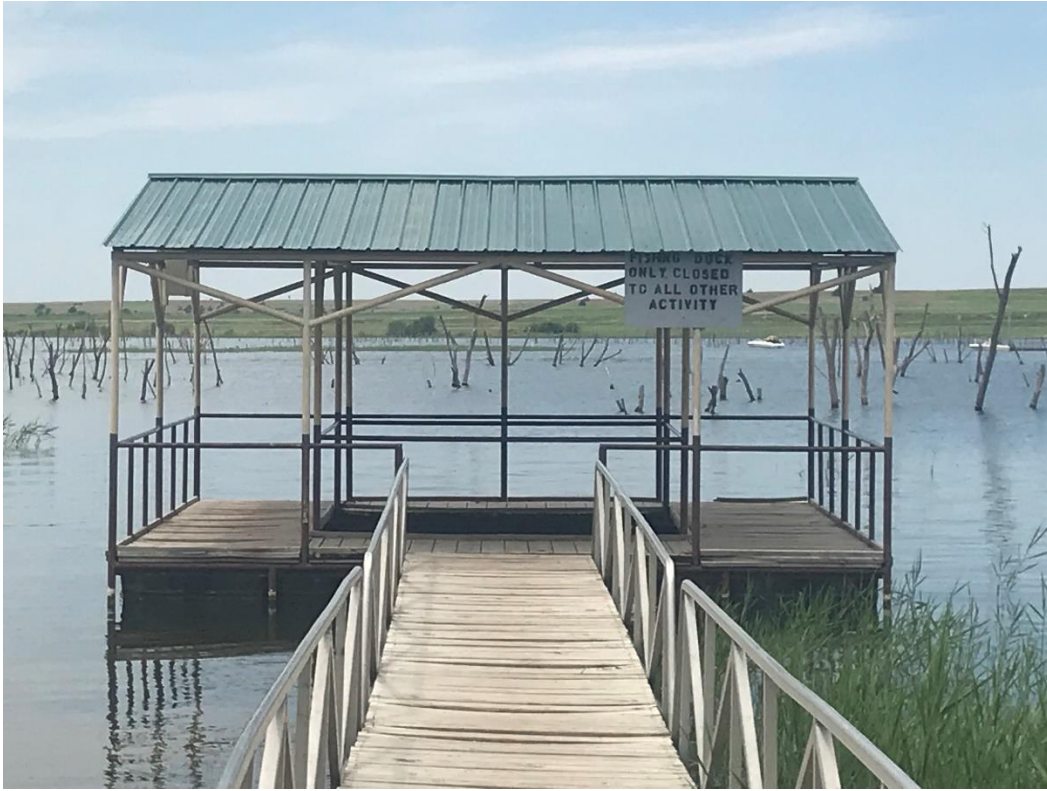
Cedar Bluff fishing dock with new, metal roof

The new roof should be a long-term upgrade that allows the dock to provide a much-needed shoreline angling access opportunity.
